**RESOLUTION ACCEPTING TOWN CENTER  
STREET TREE INVENTORY AND ASSESSMENT REPORT**

# Tree Inventory & Assessment

The City of Forest Grove  
Forest Grove, OR

Prepared by:  
Oregon Tree Care  
PO Box 13068  
Portland, OR 97213

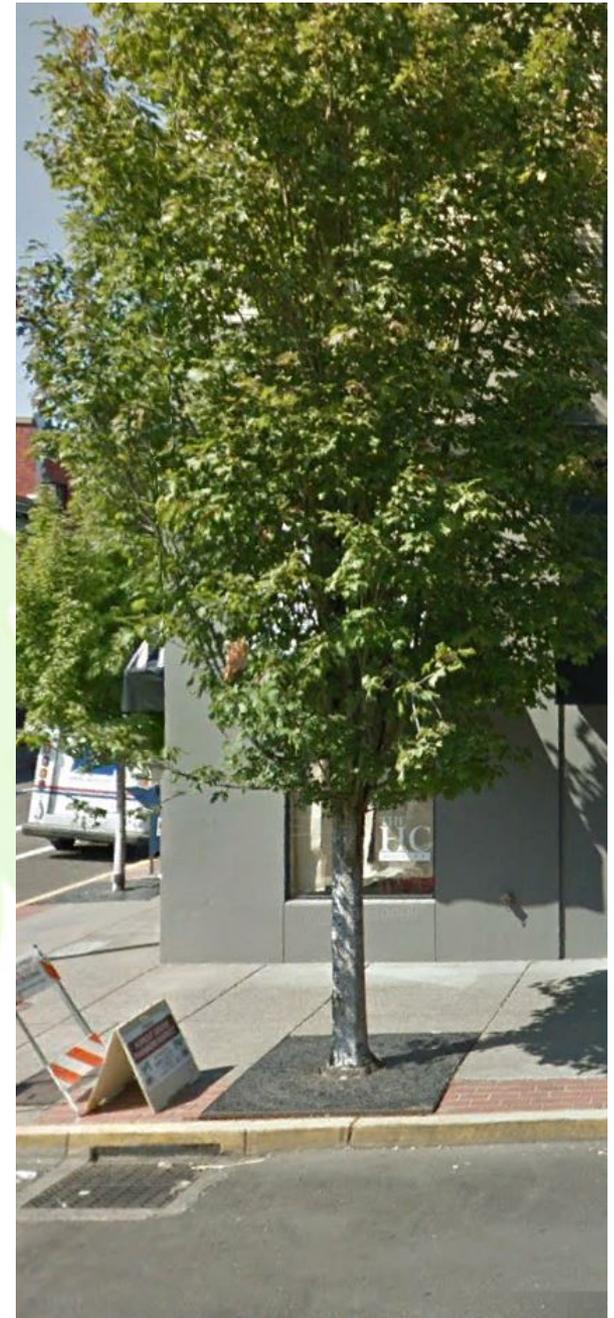
- Many street trees in the Town Center were planted more than twenty or thirty years ago.
- Some trees have grown quite large and have caused damage to sidewalks and infrastructure.
- A number of trees have been constrained by tree grates causing damage to the trees.

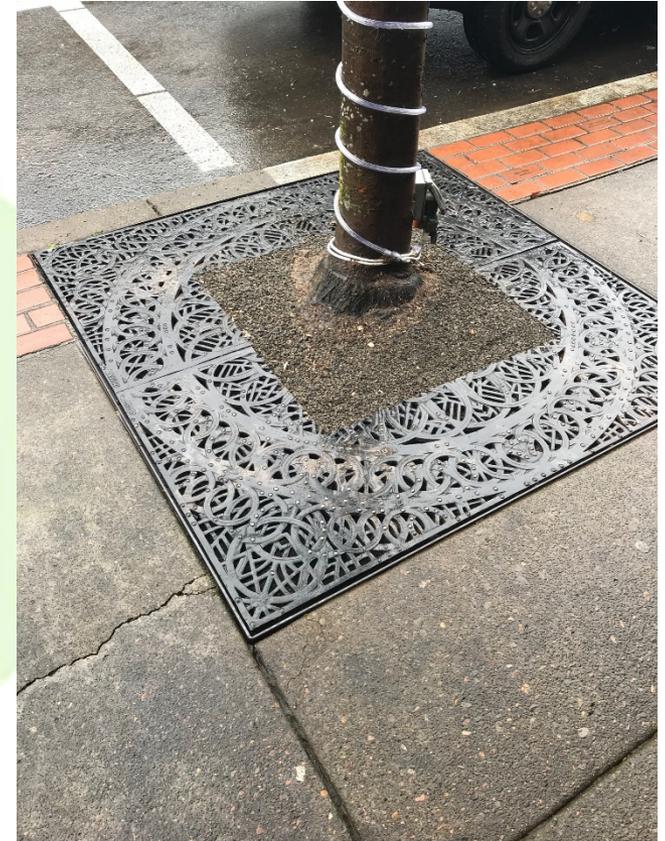
- In some cases the grates were being lifted creating a tripping hazard.
- Public Works addressed this issue:
  - 96 tree grates were inventoried by Public Works;
  - 65 needed attention because of inadequate area for the tree trunk or lifting;
  - 5% (5 of 96) were causing damage to the tree; and
  - Some grates were altered or removed.

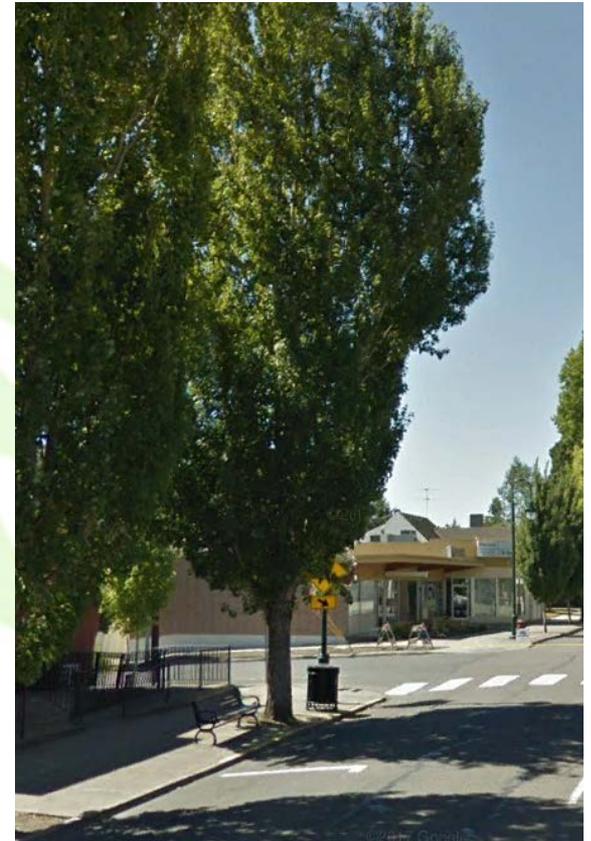
- 24 trees are causing conflicts with streets, sidewalk or parking lot clearance and need pruning.
- 8 trees are noted as having recent cuts to roots or tree base and/or damage from surrounding tree grates. Public Works recently attended to the grates to prevent further damage.
- 4 trees were identified as being in need of upper crown and/or structural pruning.
- 30 trees are affected by compacted soil resulting in exposed or girdled roots.

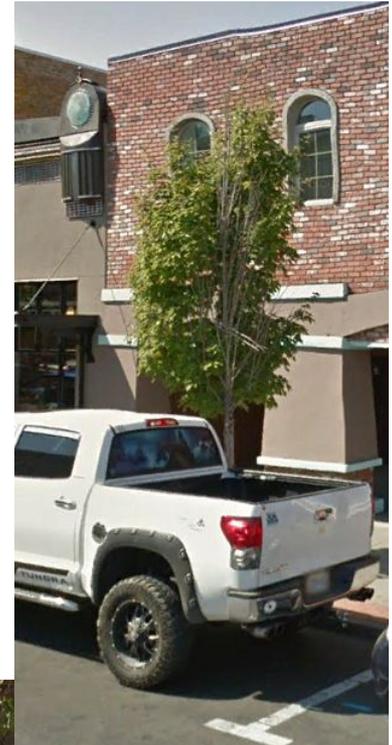
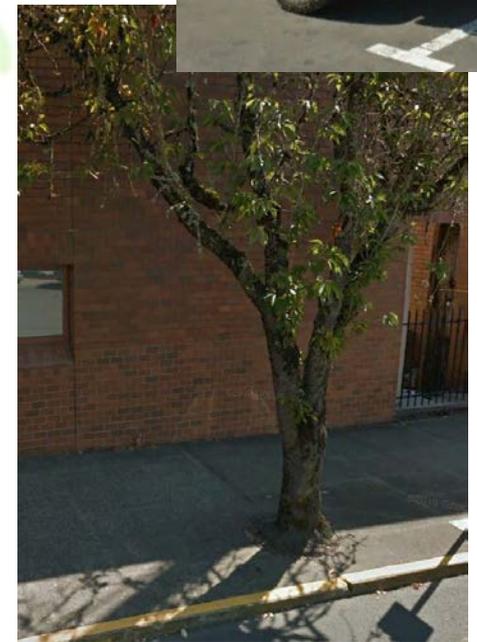
- Eight trees are recommended for removal:
  - (1) Maple on Main Street adjacent to the Adelante Mujeres office. This tree was damaged when the oak near the UCC recently fell. Tree replacement is a condition of approval for Adelante's construction project.
  - (1) Maple on B Street adjacent to Site B.
  - (2) Flowering plum on Pacific Avenue adjacent to Library.
  - (1) Flowering plum on Pacific Avenue near Post Office.
  - (1) Flowering plum on Ash Street adjacent to PD.
  - (1) Maple on Ash Street north of City Hall parking lot.
  - (1) Maple on Council near City Hall parking lot.

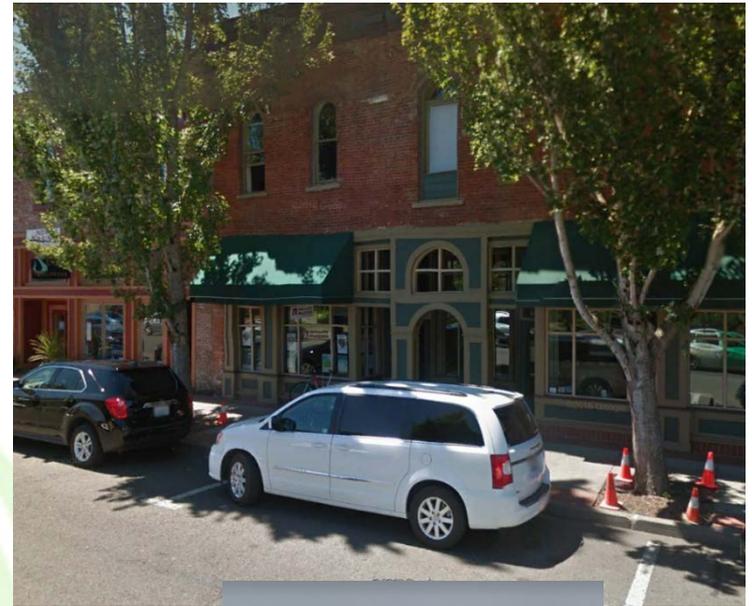
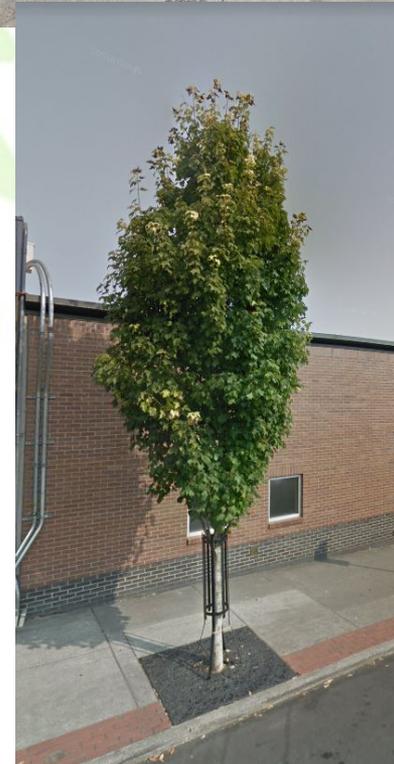
- 22 maple trees exist on Main Street between 19<sup>th</sup> & 22<sup>nd</sup> Ave.
- 2 large maple trees were removed last year on Main Street south of 21<sup>st</sup> Avenue due to sidewalk damage.
- 7 trees require attention due to decay, pruning, and damage caused by metal guards intended to protect the trees from pedestrians after replanting.
