## Memorandum

# Historic Landmark Review Staff Report and Recommendation

**Request:** Window Replacement at the James T. Buxton (a.k.a. Moore) House

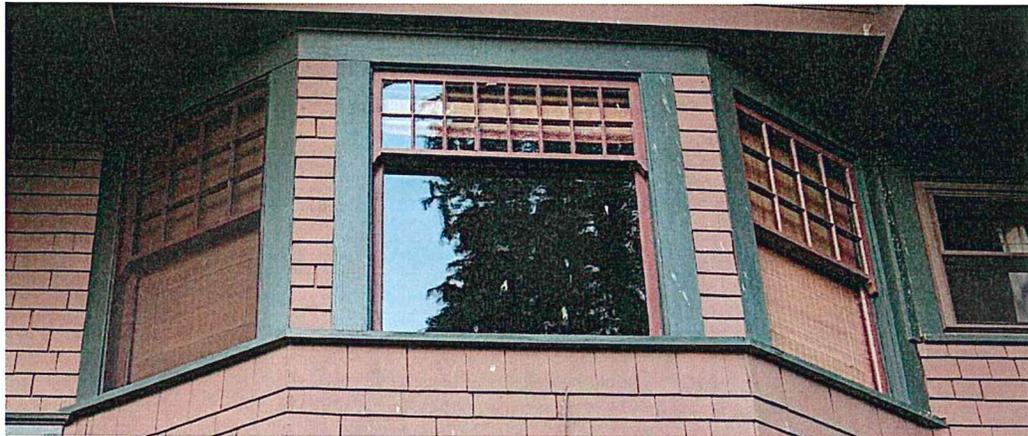
Second Floor West Bay (3)

- *The leaded glass in a diamond pattern in one window may not be replicated; and*
- *The 16-over-1 window would be replaced with a 1-over-1 window in the second-story bay.*

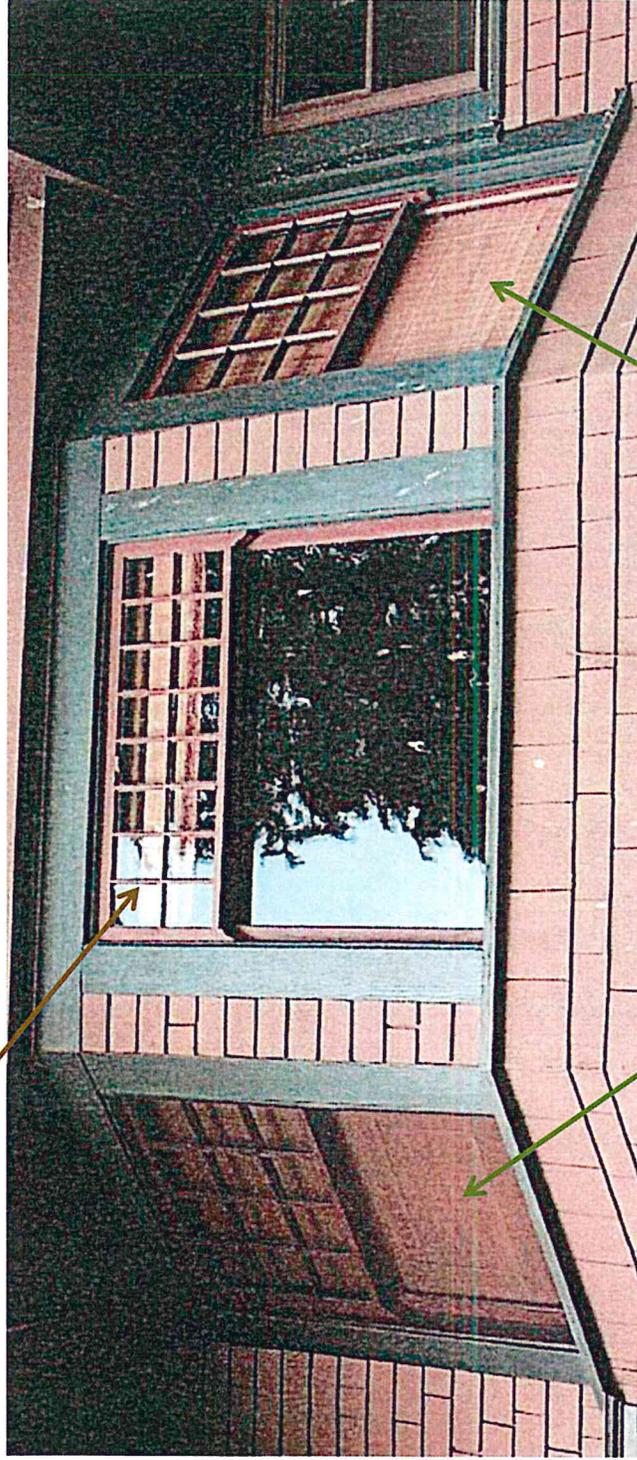
Second Floor West Bay (3)

Replace 16-panes  
with a single pane

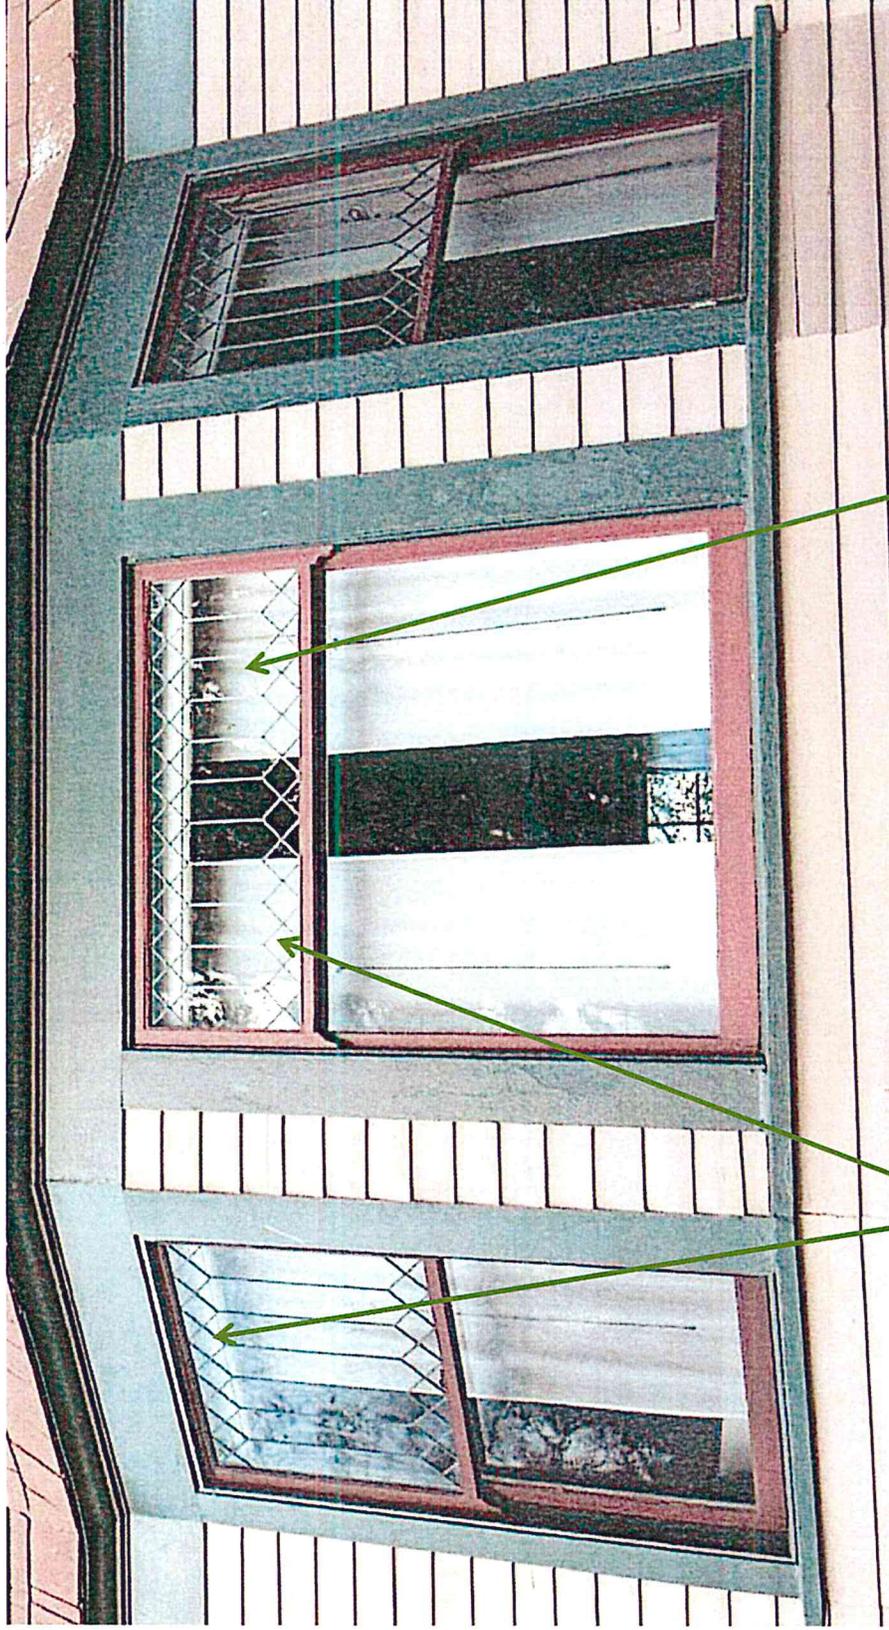
# First Floor Bay Window

Diamond pattern proposed to be replicated; but no design submitted

Leaded glass appearance would not be replicated
