# Preserving Forest Grove

Newsletter of the Historic Landmarks Board

## Masonry Buildings in Forest Grove

Article and Photographs by Neil Poulsen, Forest Grove Historic Landmarks Board

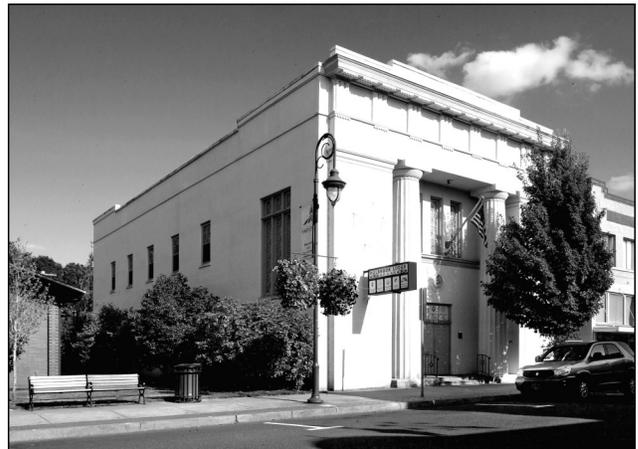
The First National Bank of Oregon on the left side of the photo below left was built in 1913. The Anderson Building across the street was built in 1917 as a clothing store. The building is constructed of bricks that rest on a concrete foundation.

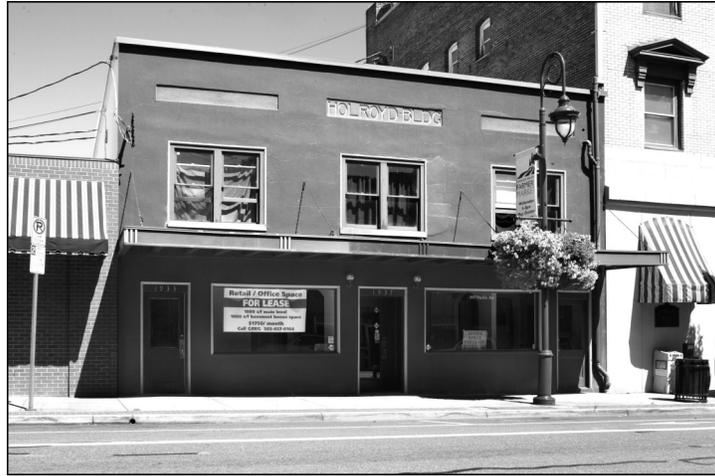
Another interesting example of masonry construction is the Holroyd Building built in 1936. This building is located at 1937 Pacific Avenue.

Whereas most Forest Grove masonry buildings were built using brick, this building has poured concrete walls that are several inches thick. Its main beam consists of a steel rail taken from the Forest Grove streetcar line. The awning on the building's front appears to be original.

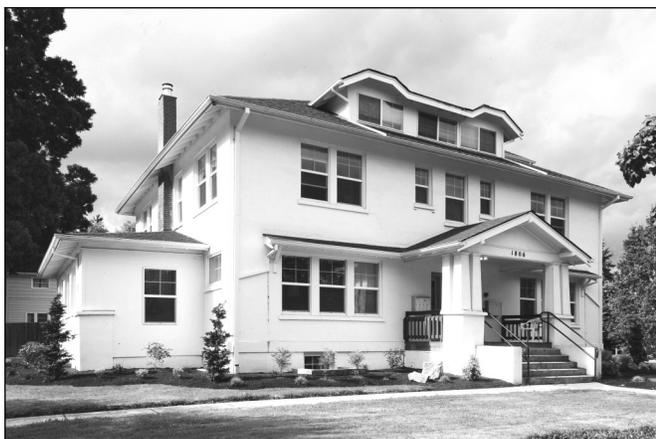
architecturally styled building located on the northwest corner of 18th Avenue and Elm Streets.

From Sanborn maps, we know that the exterior walls of this building consist of two, three-inch thick concrete walls that are separated by a two-inch wide vertical space.

An excellent example of Taylor construction is this large, east-facing arts and crafts

One cannot discuss Forest Grove's masonry buildings without giving special mention to John Taylor's hollow concrete-wall constructed buildings. A Forest Grove resident, he received a patent for his method in 1924. He and his brothers formed the Thormost Building Corporation in 1923 to promote and build these buildings. Their construction consists of two shells of concrete that are separated by a vertical air-space. Horizontal, metal reinforcing rods extend between the two concrete shells to maintain their proper alignment and add strength. Copies of Thormost Building Corporation promotional materials are available for review in the Eric Stewart Collection at the Forest Grove Library.

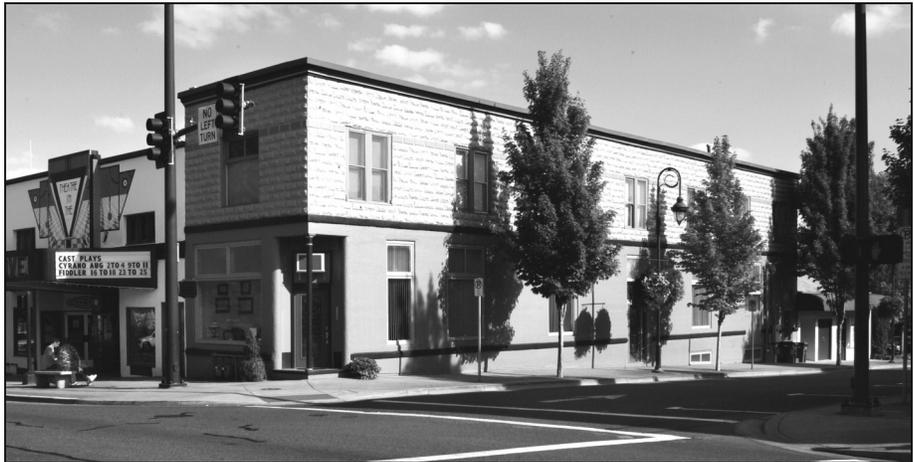
*Leakage:* Water can enter and damage a masonry building at places where masonry components in a building join. For example, this was a problem on the south wall of the Masonic Lodge mentioned above. Their solution was to protect the wall with a non-masonry siding. Unfortunately, this solution detracted from the architectural character of the building.
