**RESOLUTION ACCEPTING TOWN CENTER  
STREET TREE INVENTORY AND ASSESSMENT REPORT**

# Tree Inventory & Assessment

The City of Forest Grove  
Forest Grove, OR

Prepared by:  
Oregon Tree Care  
PO Box 13068  
Portland, OR 97213

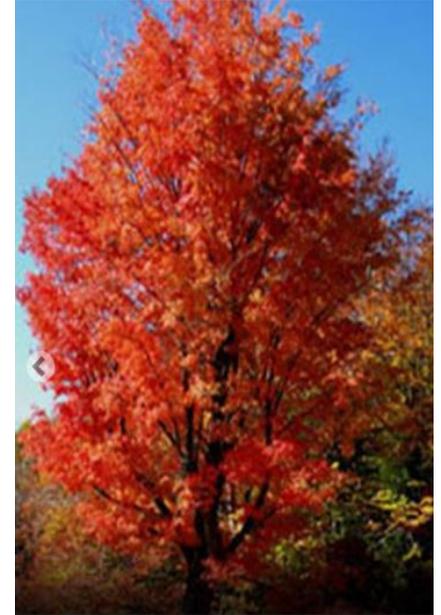
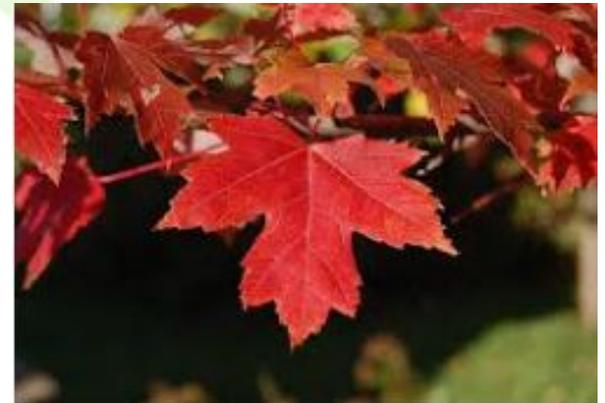
- 24 trees are causing conflicts with streets, sidewalk or parking lot clearance and need pruning.
- 8 trees are noted as having recent cuts to roots or tree base and/or damage from surrounding tree grates. Public Works recently attended to the grates to prevent further damage.
- 4 trees were identified as being in need of upper crown and/or structural pruning.
- 30 trees are affected by compacted soil resulting in exposed or girdled roots.
