Joint Water Commission

Seismic Hazard Mitigation Study

**TECHNICAL MEMORANDUM NO. 8
PIPELINE PROBABLE MAXIMUM LOSSES**

October 2008

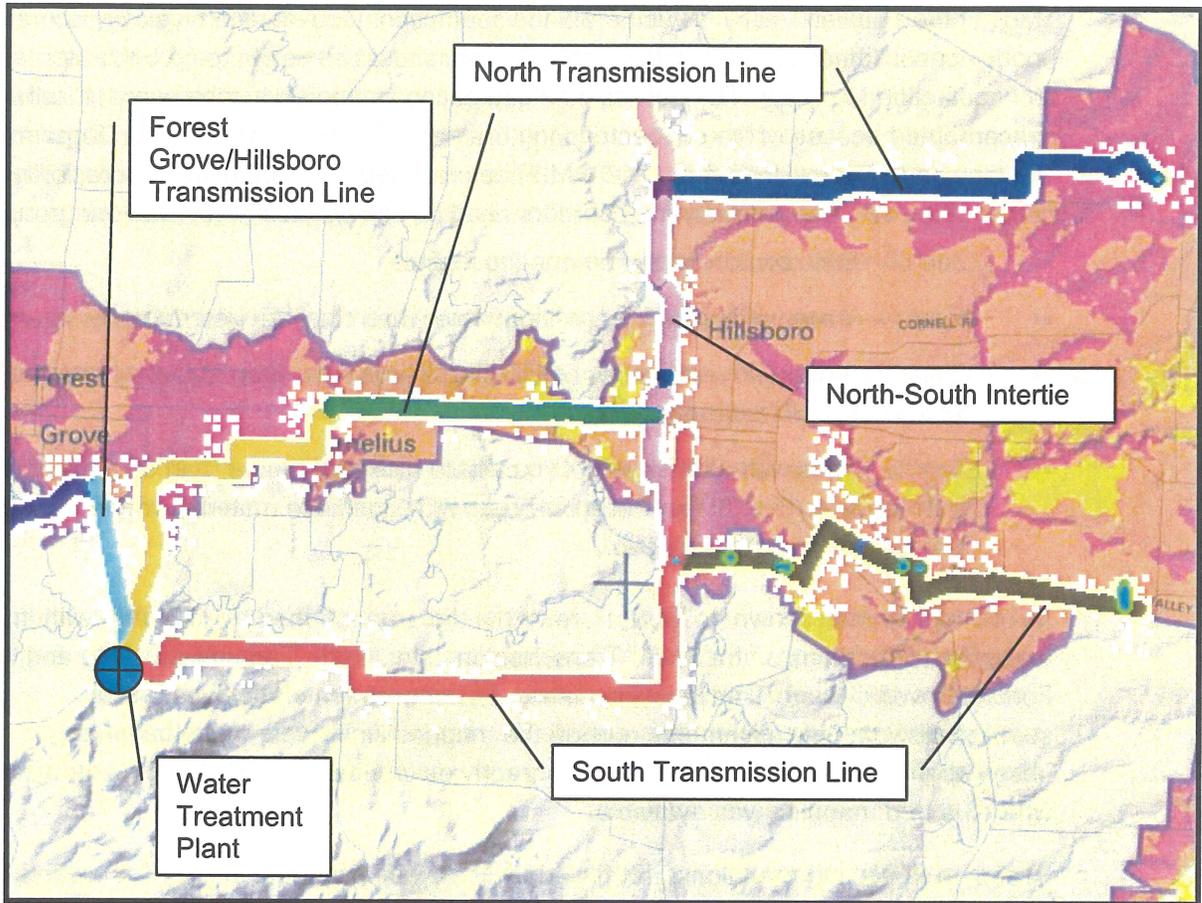
Figure 1 JWC Transmission System Overlaid on DOGAMI Liquefaction Hazard Map

The JWC transmission system consists of approximately 120,000 linear feet (LF) of large diameter concrete cylinder pipe, 30,000 lf of welded steel pipe and approximately 4,000 lf of ductile iron pipe. Pipe diameters range from 18-inch to 72-inch. Refer to Table 1 for greater detail. The pipelines begin at the WTP and move water northward and eastward to the retailer systems, as shown in Figure 1.

All of the pipe lines shown in Table 1 are within the area mapped by DOGAMI with the exception for portions of the South Transmission Line, North Transmission Line and the Forest Grove/Hillsboro Transmission Lines. An assessment of the liquefaction susceptibility of these alignments outside the mapped limits was made based on observation and interpretation of the topography as compared to that of the nearby area where hazard mapping was available.
